NASA TECHNICAL
MEMORANDUM

NASA TM X-53548
November 21, 1966

INVESTIGATIONS OF MONOLITHIC
INTEGRATED CIRCUIT FAILURES

by Kenneth W. Woodis
Quality and Reliability Assurance Laboratory

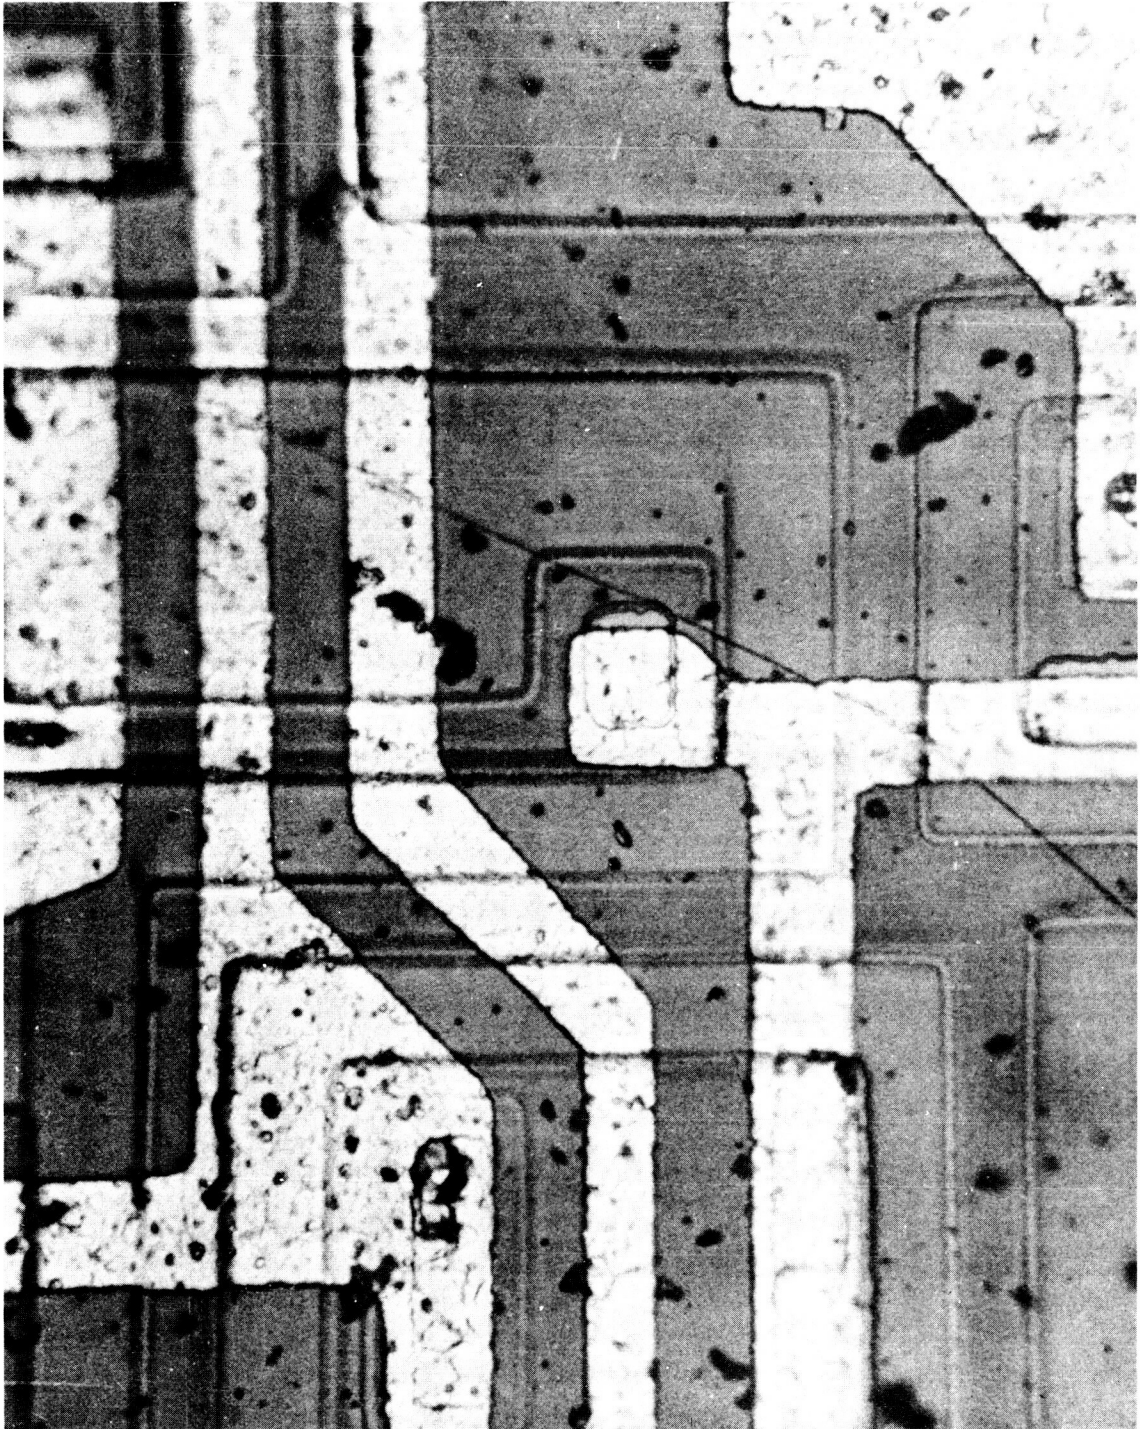
There were several mechanisms which indicated improper handling of the die. Figure 15 shows a die that was cracked through a transistor and a resistor area. Figure 16 shows damage that was probably caused by improper use of a microprobe or a tool used to position the die.

Figure 15. A Die Cracked Through a Transistor and a Resistor Area

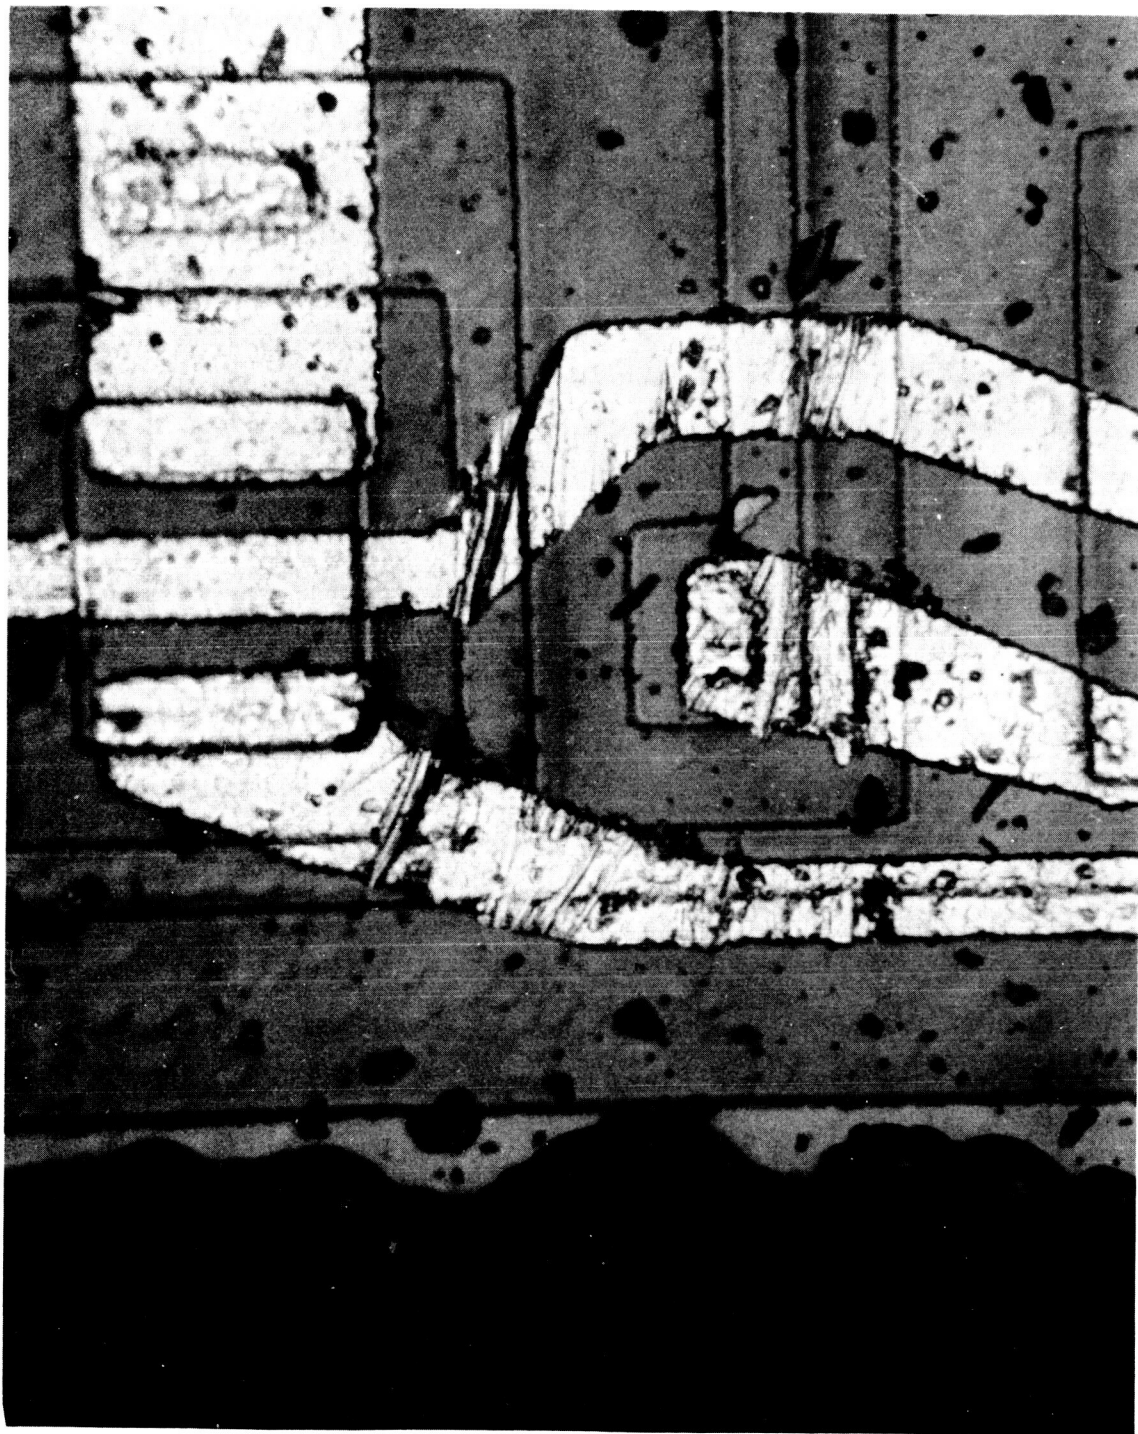
Figure 16. Damage Caused by Improper Use of a Microprobe or a Tool Used to Position the Die

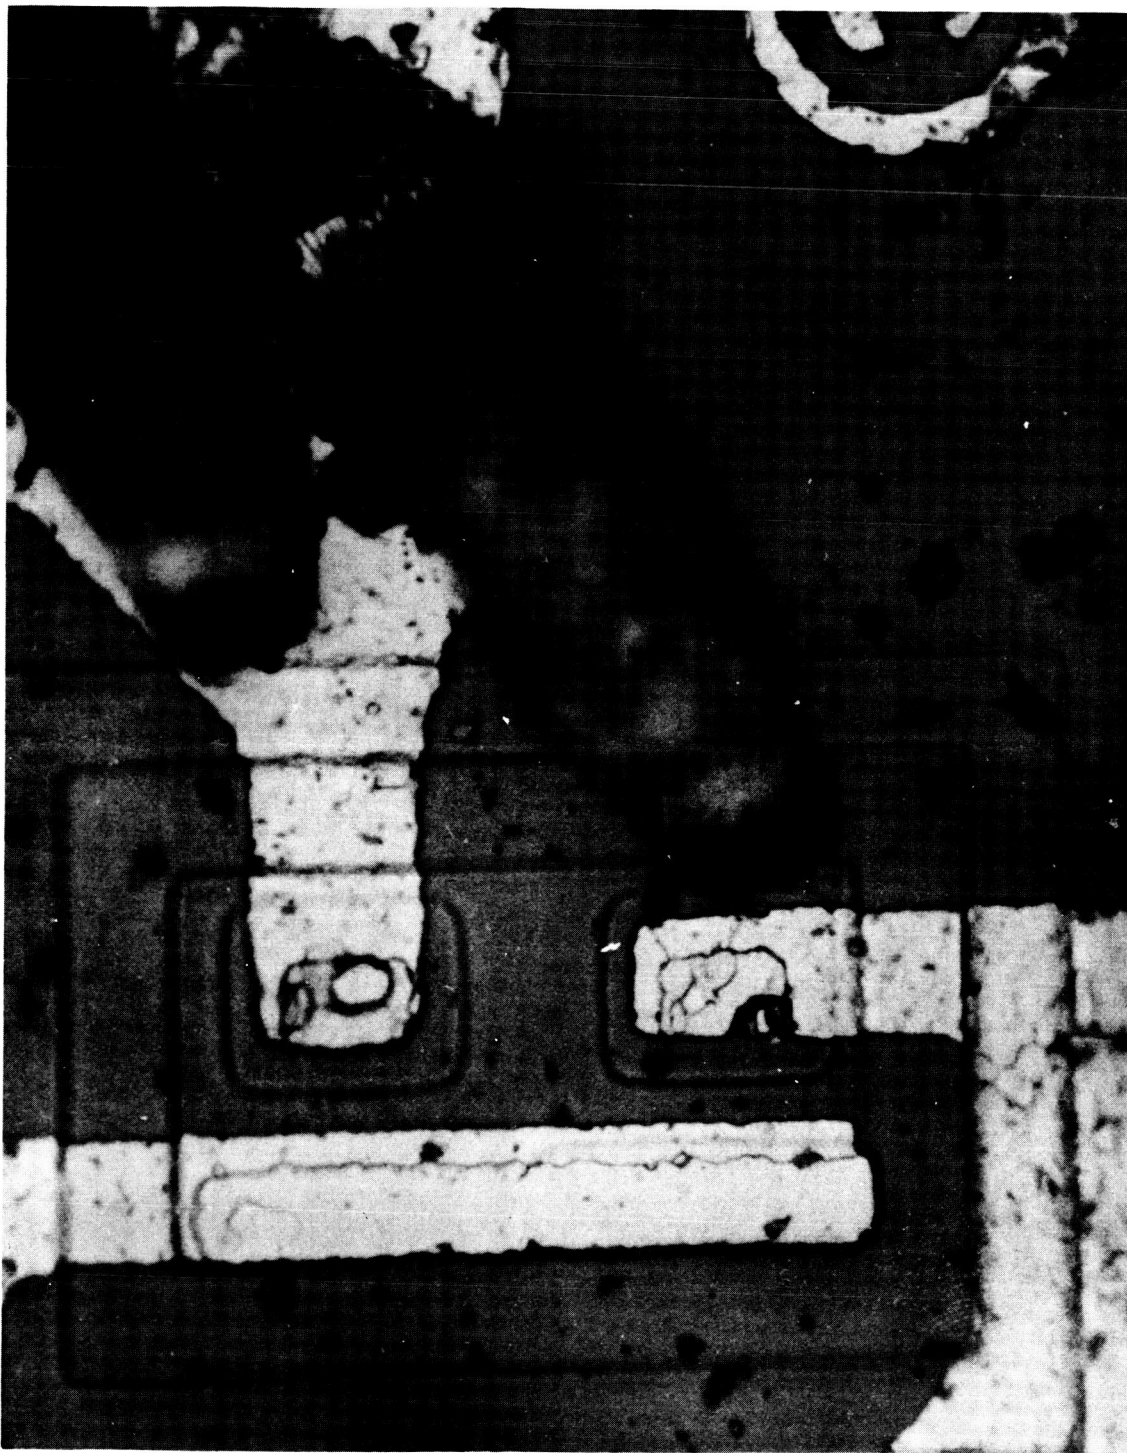
Another serious problem found was the double bonding of input-output leads. Figure 17 shows a lead that was broken off and another bonded next to it, while figure 18 shows a bond in which the aluminum and part of the insulation below it were torn away; thereby shorting the pad to the lower layers of the die.

Figure 17. Double Bonding of Input-Output Leads

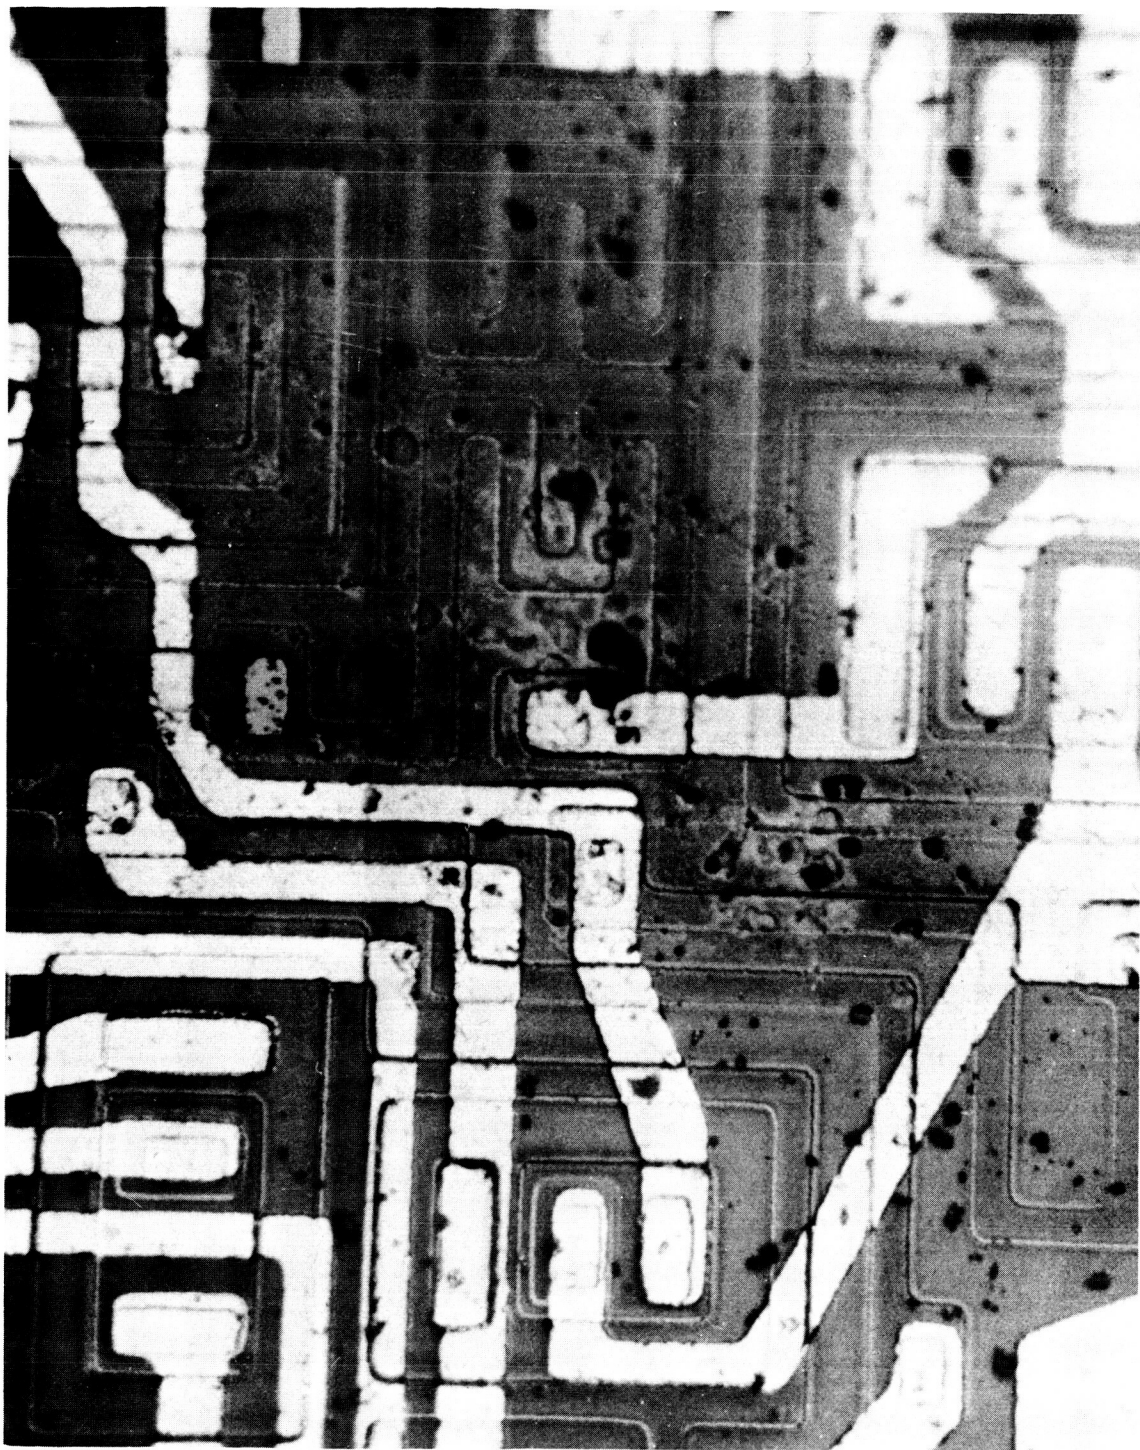
The last series of pictures presents units which had been subjected to alumina hydration and chemical degradation. Figure 19 clearly shows a case where moisture or the etchant used on the die was not completely removed. Figure 20 presents the case where an etchant has been allowed to contact an aluminum lead thereby eating the aluminum lead in half. Figure 21 shows alumina hydration taking place on the aluminum.

Figure 19. Etchant on Die Not Completely Removed

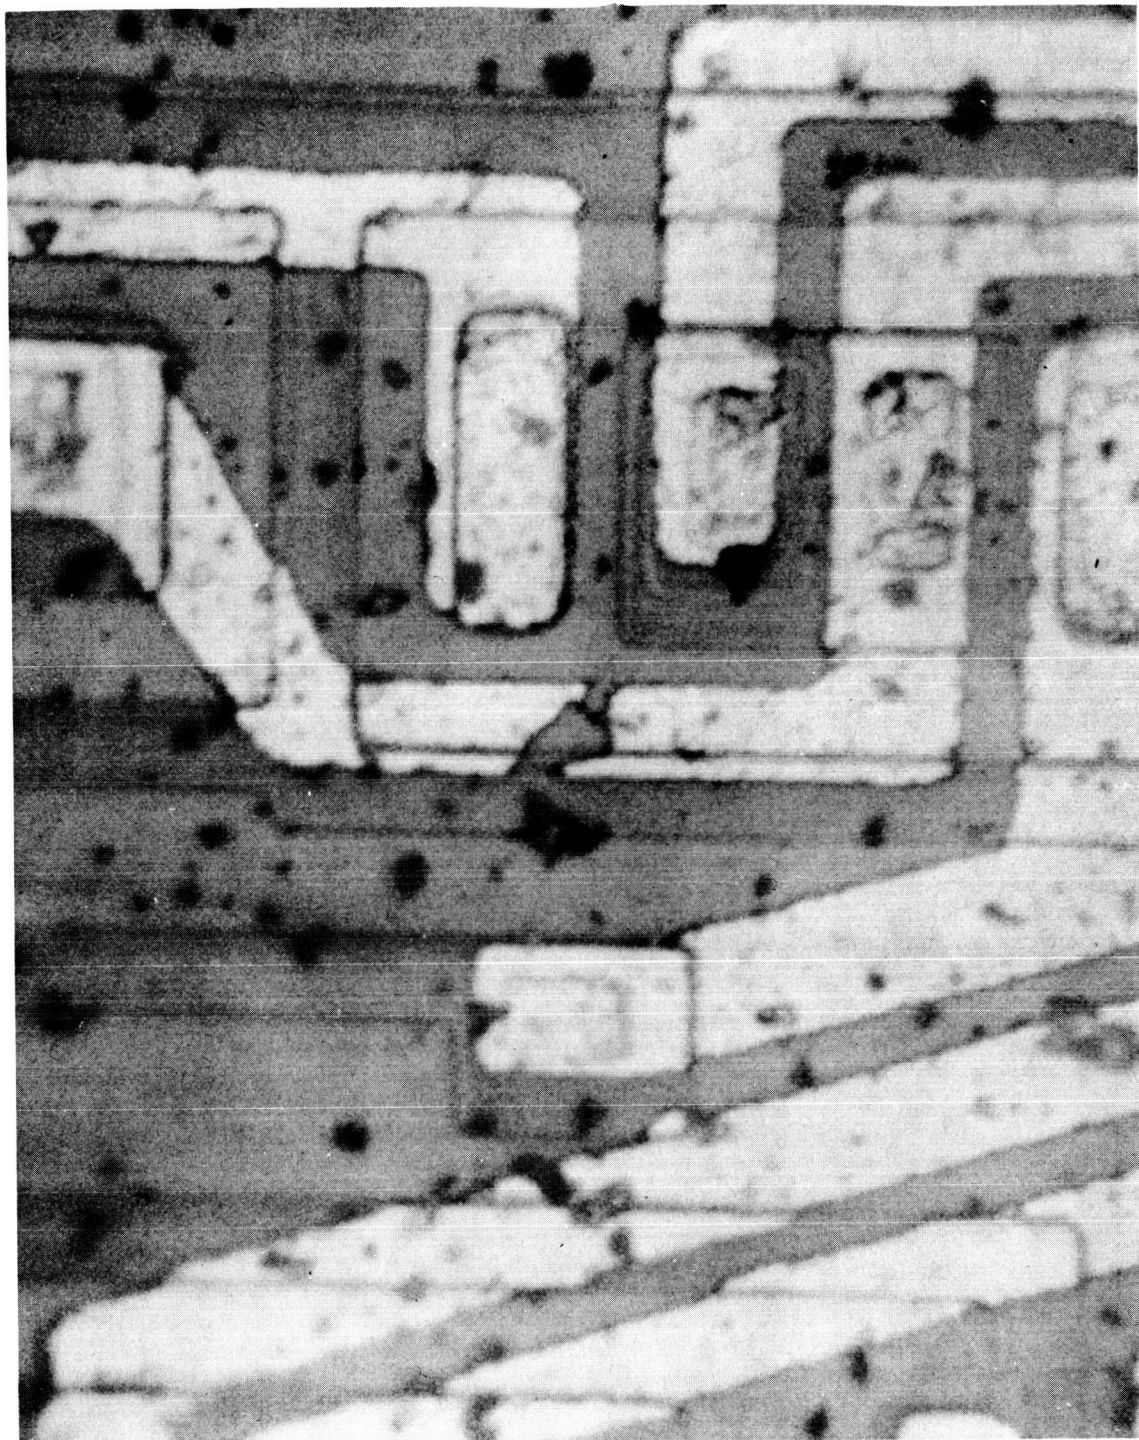
When the unit pictured in figure 20 was inspected, it was decided that a more extensive analysis of the affected aluminum leads was in order. This would involve either using an electron microscope analysis or actually scraping off some of the affected area and using x-ray diffraction methods to analyze the compound; however, this would be out of our present scope of work and was not performed.

Figure 20. Aluminum Lead Damaged by Etchant

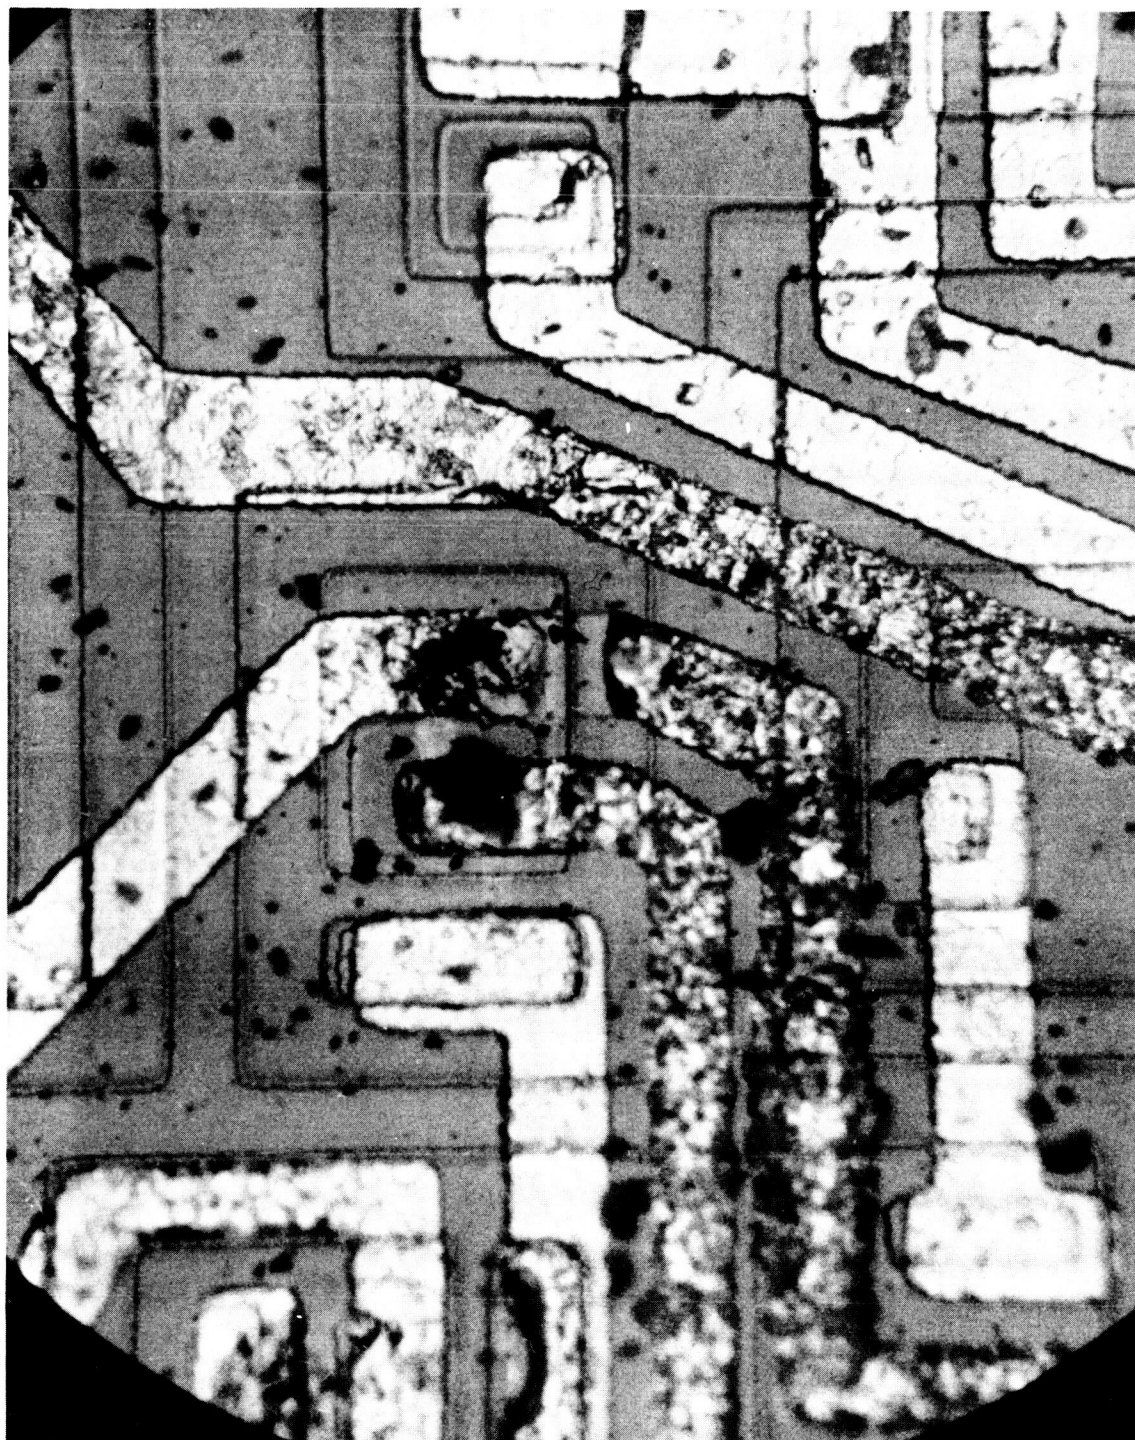
Figure 21. Chemical Reaction on Aluminum
